**AN INVESTIGATION OF DRIVELINE INCIDENTS OF
THE US ARMY'S MODEL M1078 LIGHT MEDIUM
TACTICAL VEHICLE (LMTV)**

REQUESTED BY:
**US ARMY TANK-AUTOMOTIVE AND ARMAMENTS
COMMAND (TACOM)**

CONTRACT NUMBER:
DAAE07-98-C-M012

14. ABSTRACT ROOT CAUSE ANALYSIS AND DEVELOPMENT OF RECOMMENDED CORRECTIVE ACTIONS FOR CRACKED FLYWHEEL HOUSINGS AND DRIVESHAFT UNIVERSAL JOINT FAILURES IN MODEL M1078 2 1/2 TON LIGHT MEDIUM TACTICAL VEHICLE 4X4 TRUCKS ARE THE PRIMARY FOCUS OF THIS REPORT. THE COMPLEX DYNAMIC SYSTEM REQUIRED SPECIALIZED INSTRUMENTATION AND MATHEMATICAL MODELING TO HELP UNDERSTAND THE PROBLEM AND PRESCRIBE CORRECTIVE ACTIONS. THIS REPORT DETAILS THE ENGINEERING INVESTIGATION CONDUCTED BY MICHIGAN SCIENTIFIC CORPORATION (MSC) AND INDEPENDENTLY BY DR. JOHN F. MARTIN OF MICHIGAN STATE UNIVERSITY DURING THE MONTHS OF APRIL 1998 THROUGH DECEMBER 1998.

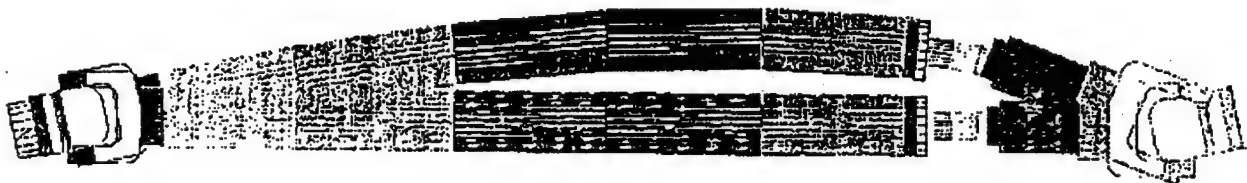
MERITOR ORIGINAL PRODUCTION DRIVESHAFT 1st MODE BENDING
(SIMPLY SUPPORTED)
MERITOR ADAMS MODEL
Frequency=72.8 Hz

Figure 5.4 Meritor ADAMS model of original production driveshaft

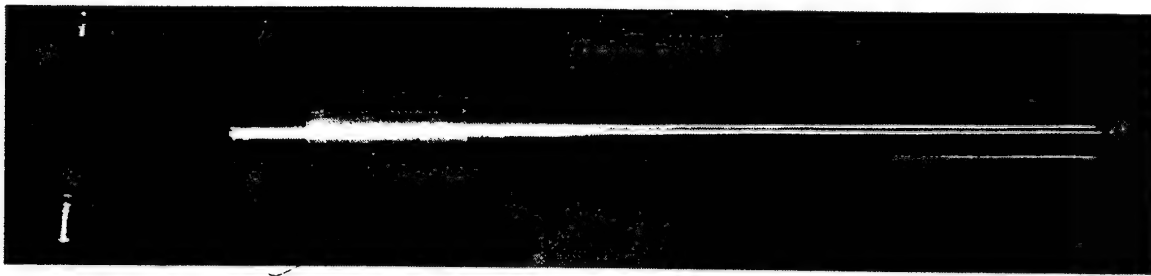
The Meritor original production driveshaft with a 2.00" O.D. splined shaft and a long 1.633" O.D. necked down portion was recognized as having a low relative bending stiffness; therefore, a tight fitting reinforcing tube was added to bridge this area of the driveshaft, see figure 5.6.

Figure 5.6 Photograph MSC proof of principle driveshaft
